AHERA DESIGNATED PERSON
for
LIGHT OF THE WORLD ACADEMY

***ORIGINAL ASBESTOS INSPECTIONS &
MANAGEMENT PLAN DOCUMENTATION
for
LIGHT OF THE WORLD ACADEMY***

NESHAPs ASBESTOS INSPECTION REPORT

Light of the World Academy

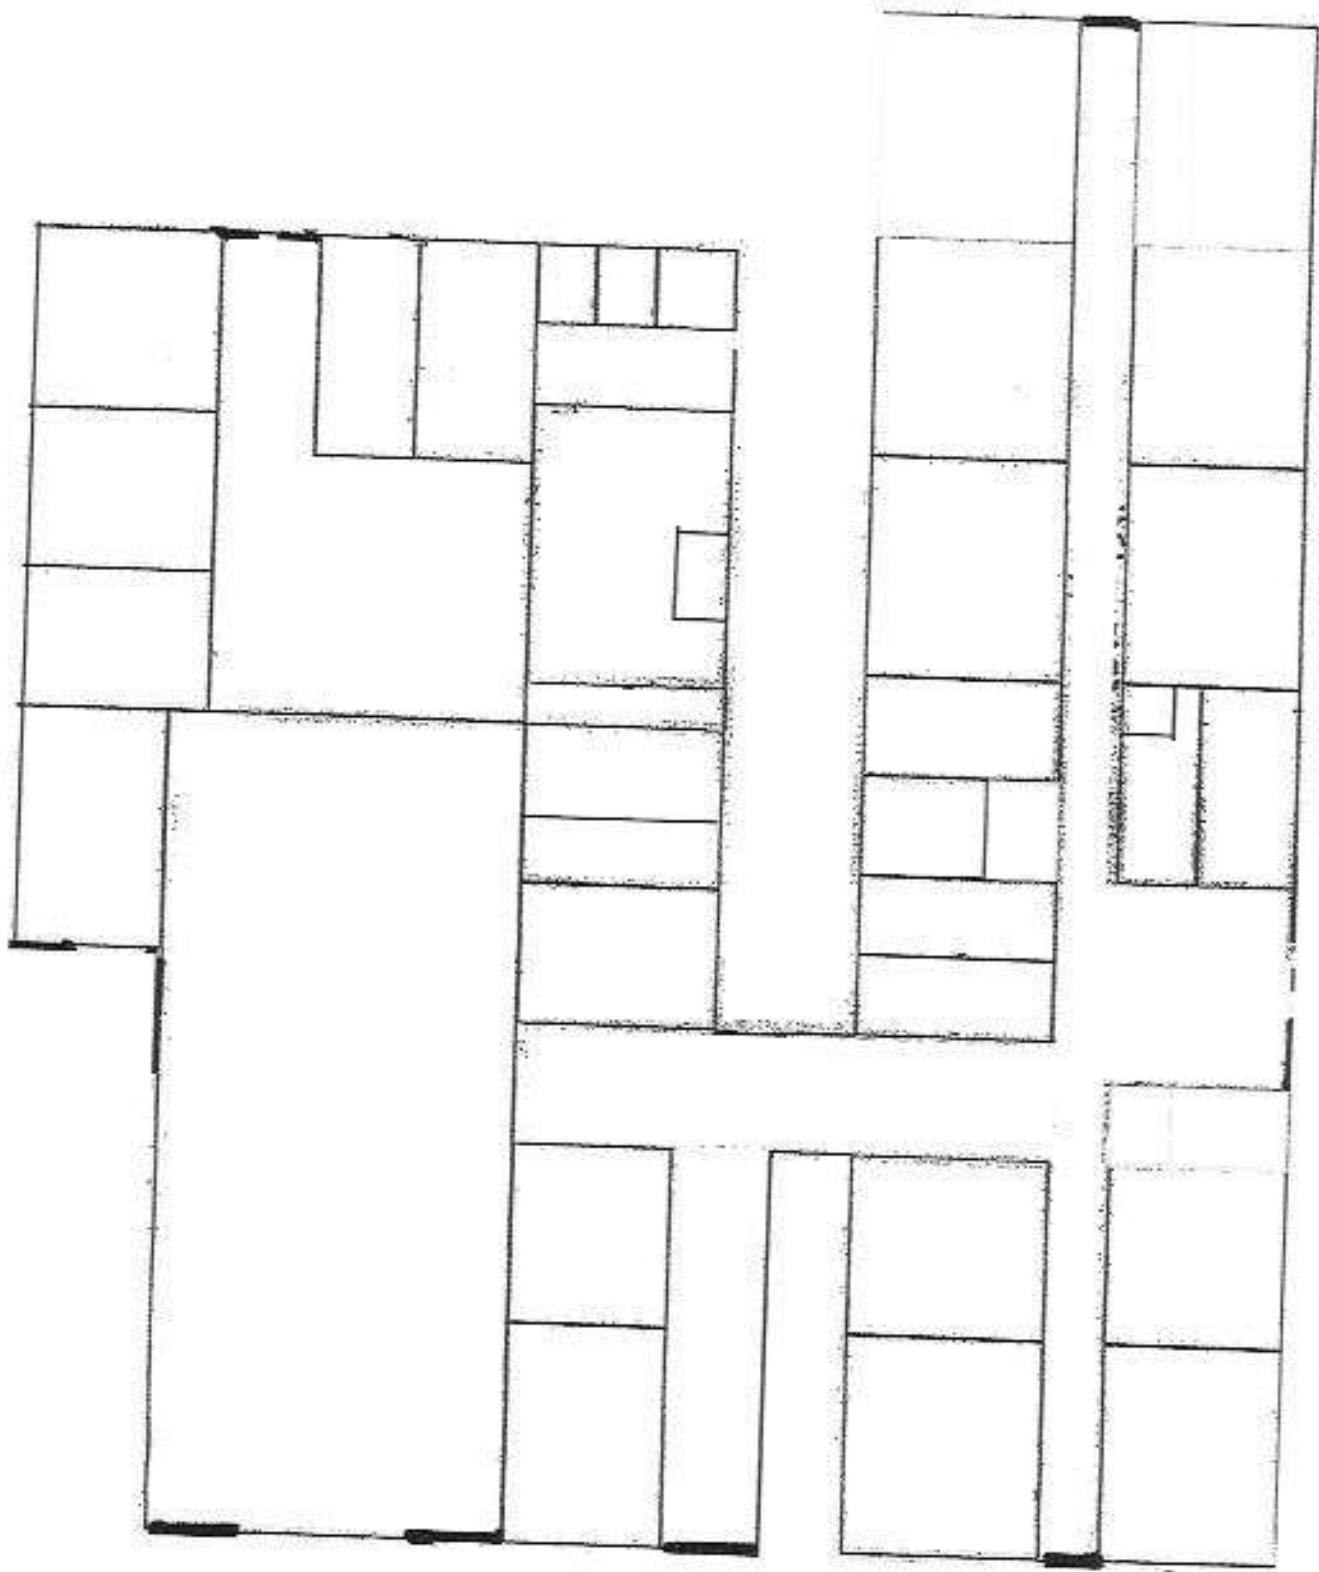
ACM Pipe Insulation Locations

The original LOTWA school building was constructed in 1952 and does contain material with asbestos content. Our study has revealed asbestos in door and window caulk and boiler pipe insulation located in our maintenance areas. We are currently maintaining these materials in a safe condition for all by our ongoing surveillance, re-inspection, and operations & maintenance program.

- North Boiler Room: Packed Pipe Insulation on Fiberglass Lines - Patch and Repair of Packed Pipe Insulation throughout North Boiler Room.
- North Boiler Room: Straight Pipe Insulation, Millboard Lines - Patch and Repair of Straight Pipe Insulation throughout North Boiler Room.
